Consultancy to Conduct a Building  
Condition Assessment of the Paramaribo  
World Heritage Site and its Buffer Zones

# FINAL REPORT OF DATA COLLECTION FOR THE PARAMARIBO HERITAGE BUILDINGS INVENTORY

OBRA STUDIO

October 2019

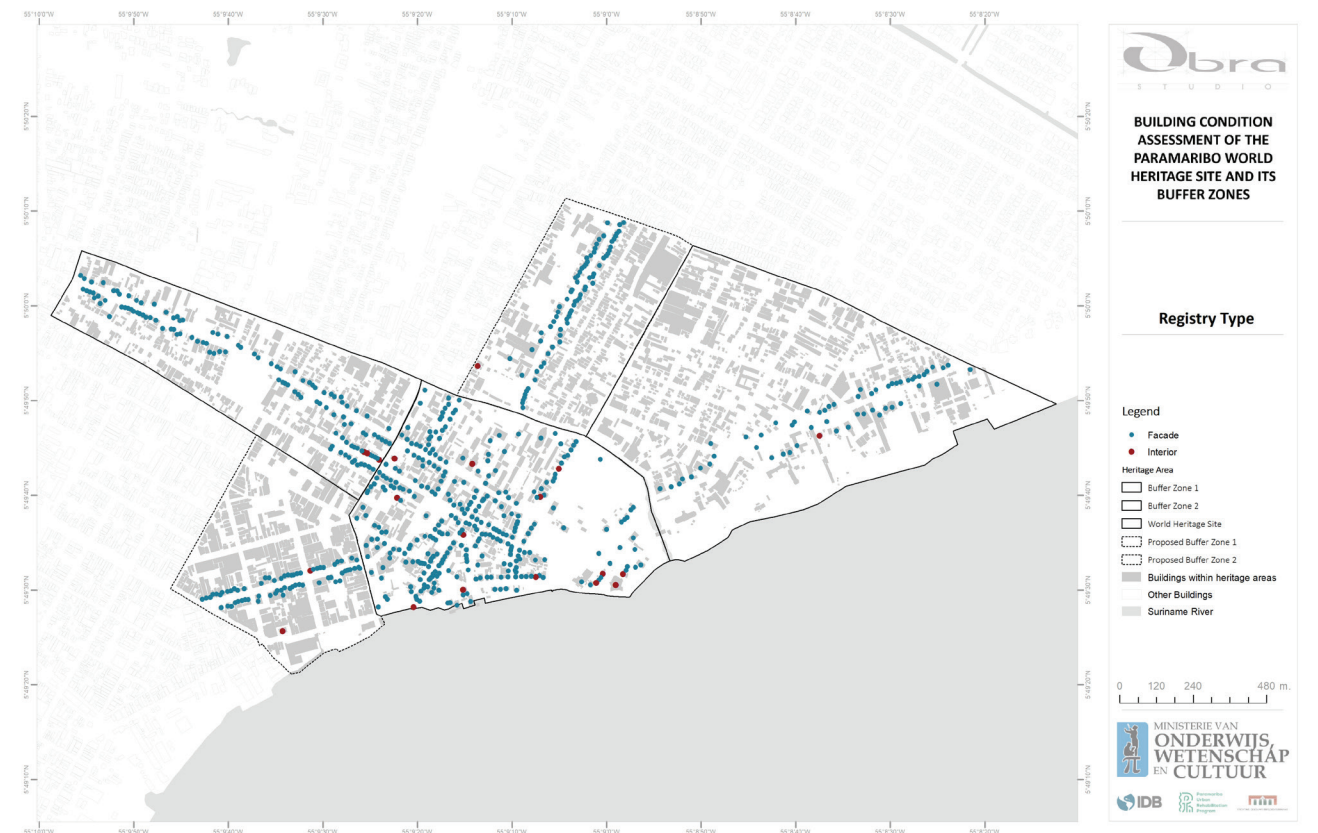
Map 1. Mapped points per registry type

All the points mapped during the field activities are depicted in Map 1, which evidences the completion of the predetermined target. As planned, the buildings that were considered were the ones that were able to be viewed from the street, which included all the ones within the WHS, 2 axis from the Buffer Zones along Cornelis Jongbawstraat and Henk Arronstraat, and 2 axis from the Proposed Buffer Zone Expansion along Prins Hendrikstraat and Maagden Straat. Also, the field researchers decided map the entire Heerenstraat to offer additional data for the ongoing projects along this street, which required surveying an additional 27 buildings.

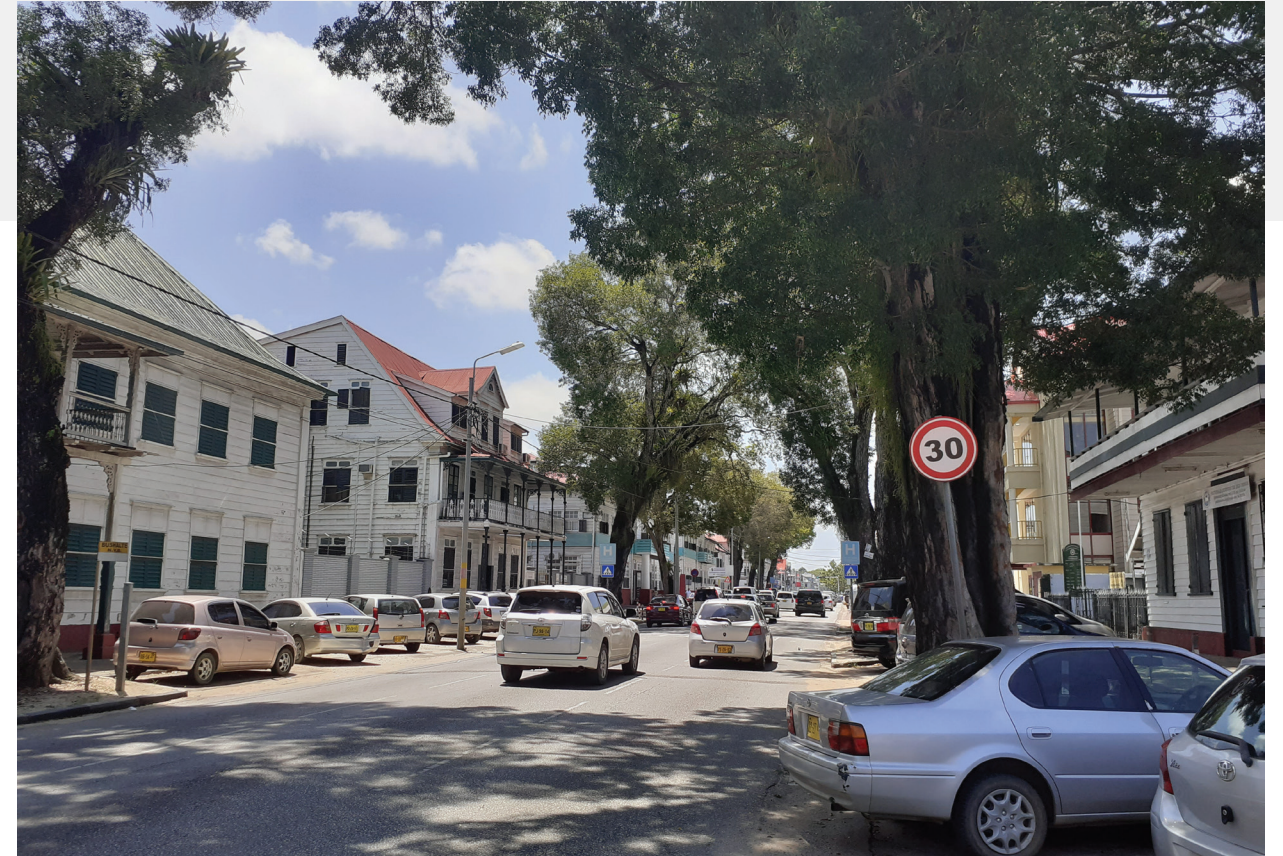
Figure 9. Cars on sidewalks

Despite the existence of sidewalks throughout PWHS, cars often park on sidewalks intervening with the pedestrians and the absence of trees means that there is no shade adding an additional factor that makes it an uncomfortable place to walk.

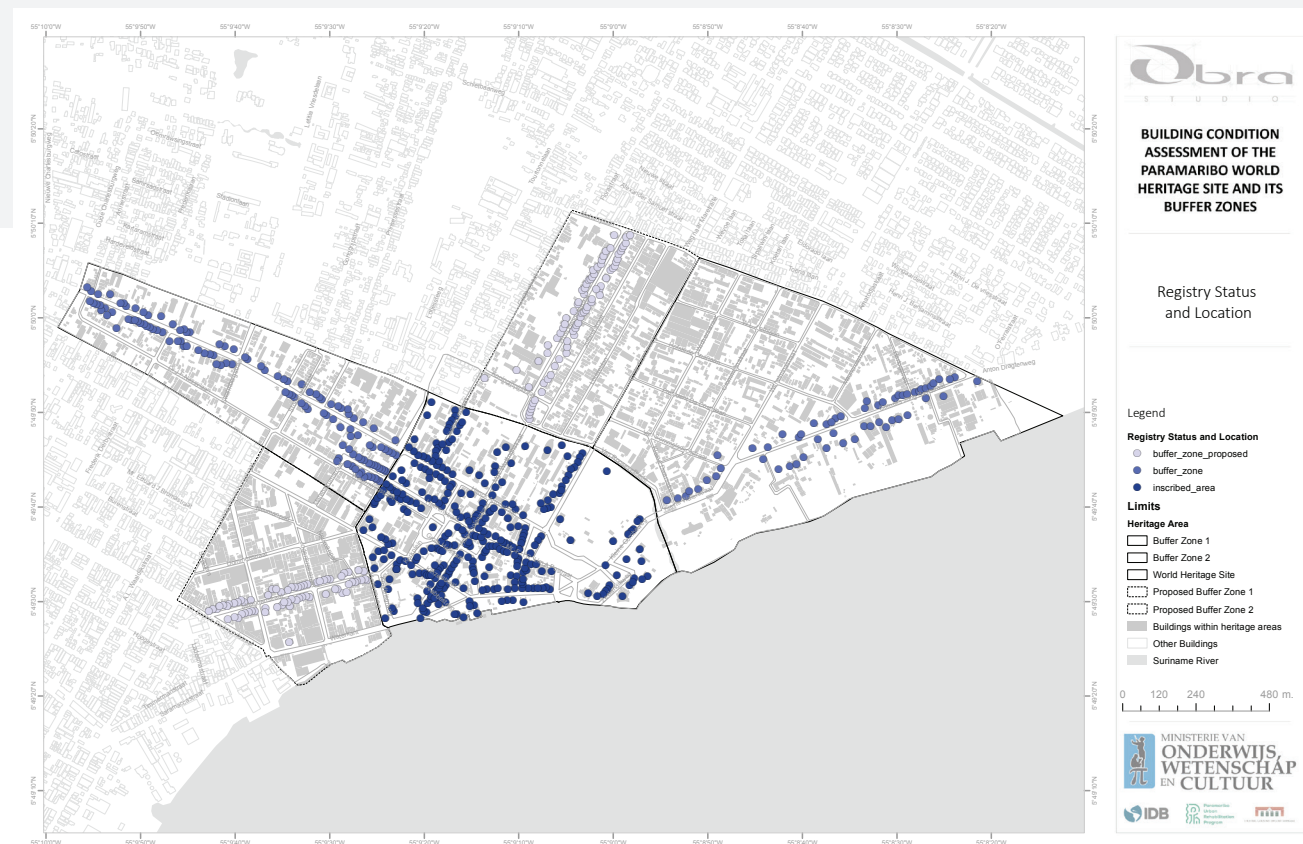
Map 5. Registry Status and Location

The “Registry Status” determines the location of the building within the different heritage perimeters that correspond to the HICP. Within the World Heritage Site –or “inscribed area” according to UNESCO’s parameters –there were 329 mapped buildings (50.7%), within the official Buffer Zones there were 177 mapped points (27.3%), and within the Proposed Buffer Zones there were 143 mapped buildings (22.0%), as shown in Map 5.

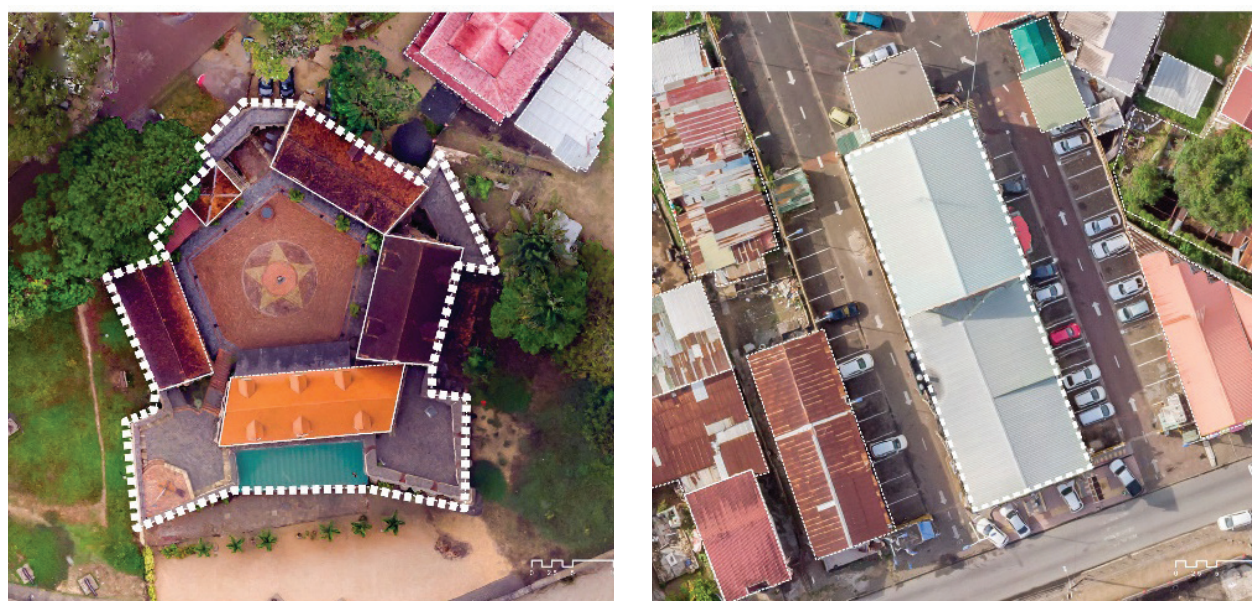
Figure 16. Aerial views of individual buildings

The individual registry reports contain information on the façade image, the building name, the author, the construction date, the parcel ID, and an aerial view of the context (figure 16 and 17). This content is valuable when analyzing each building individually, but it is of great importance to evaluate the results from the typology analysis, since it outlines the buildings that have historic importance and should have a different priority for renovation. Figure 18 and map 6 show how these different typologies are distributed on the territory. .

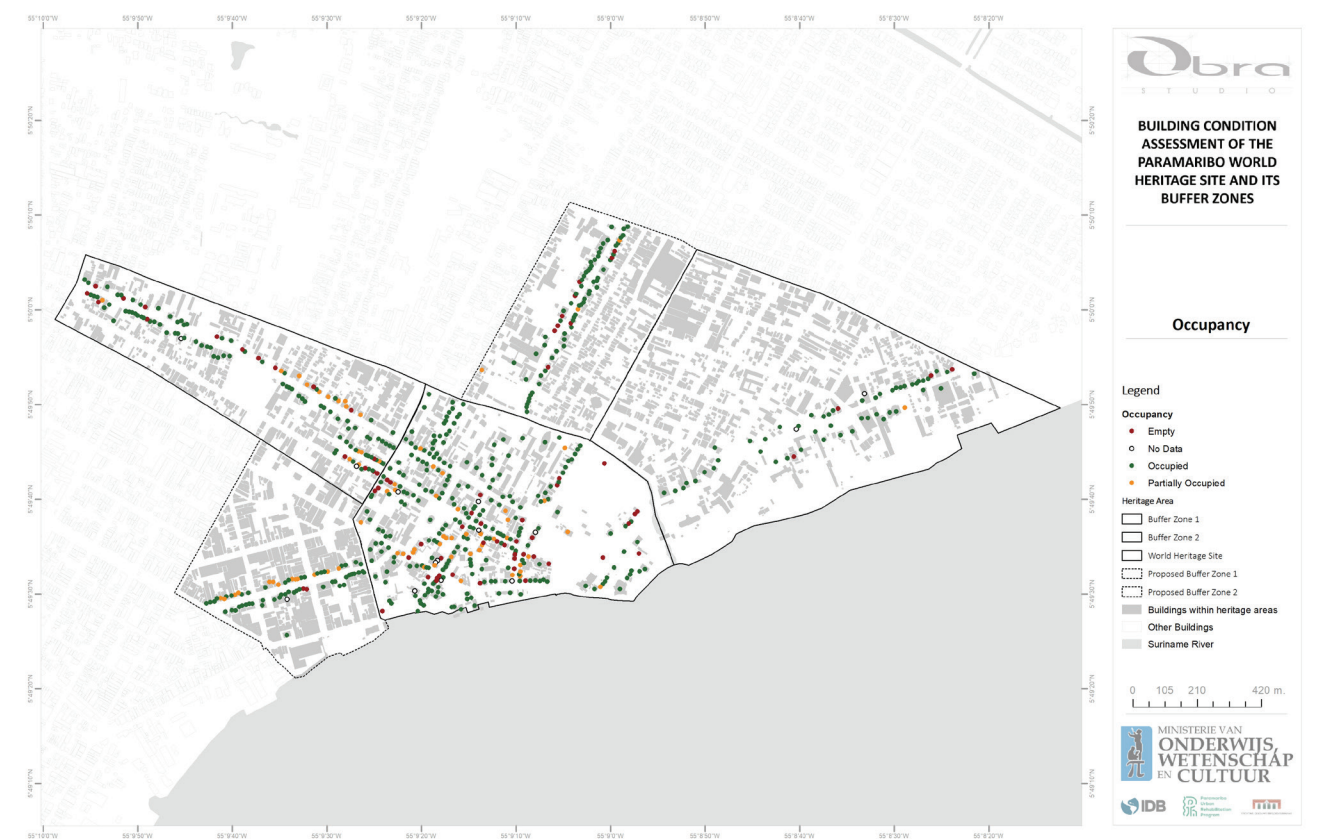
Map 12 Occupancy

The data demonstrates almost a 75% occupancy rate, where 22% of the buildings are either empty or partially occupied. This lack of occupancy appears focalized on certain street blocks (map 12), including: the southern section of Watermolenstraat and Dr. J.C. Mirandastraat, the northern section of Heerenstraat, and along certain sections of the buffer zones’ axis.

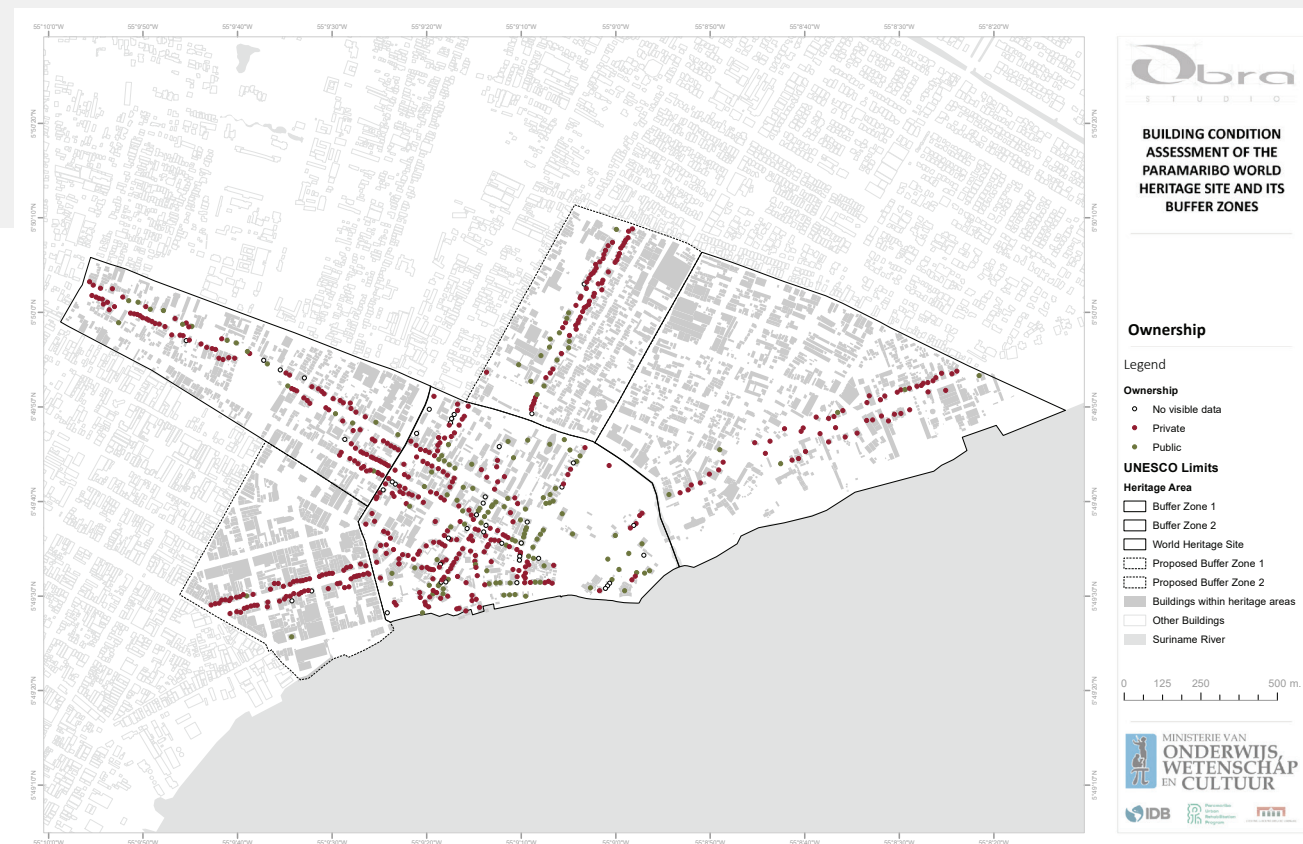
Map 13. Ownership

In general, ownership could be perceived from the street, since all governmental and other public institution have clear signs detailing their name and purpose. As a result, 71.8% of ownership was found to be private and 20.6% public. Different intervention strategies should be prepared for this reality, considering incentives for private investment, but also the need to prioritize intervention on public buildings that have historic value.

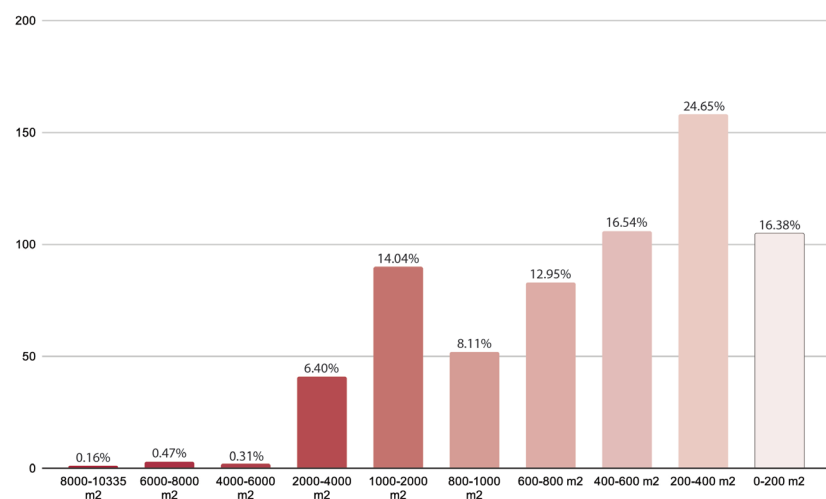
Figure 25. Total Floor Area

The geo-referenced polygon data for the buildings can be multiplied by the above building height information, to determine a total floor area for each building. Figure 25 shows the distribution of these values, demonstrating that most buildings correspond to less than 500 square meters, but over 10% of the buildings have a floor area of over 2500 square meters. Map 15 uses the total floor area information to demonstrate, the distribution of these points in the area (showing how they appear close to main roads).

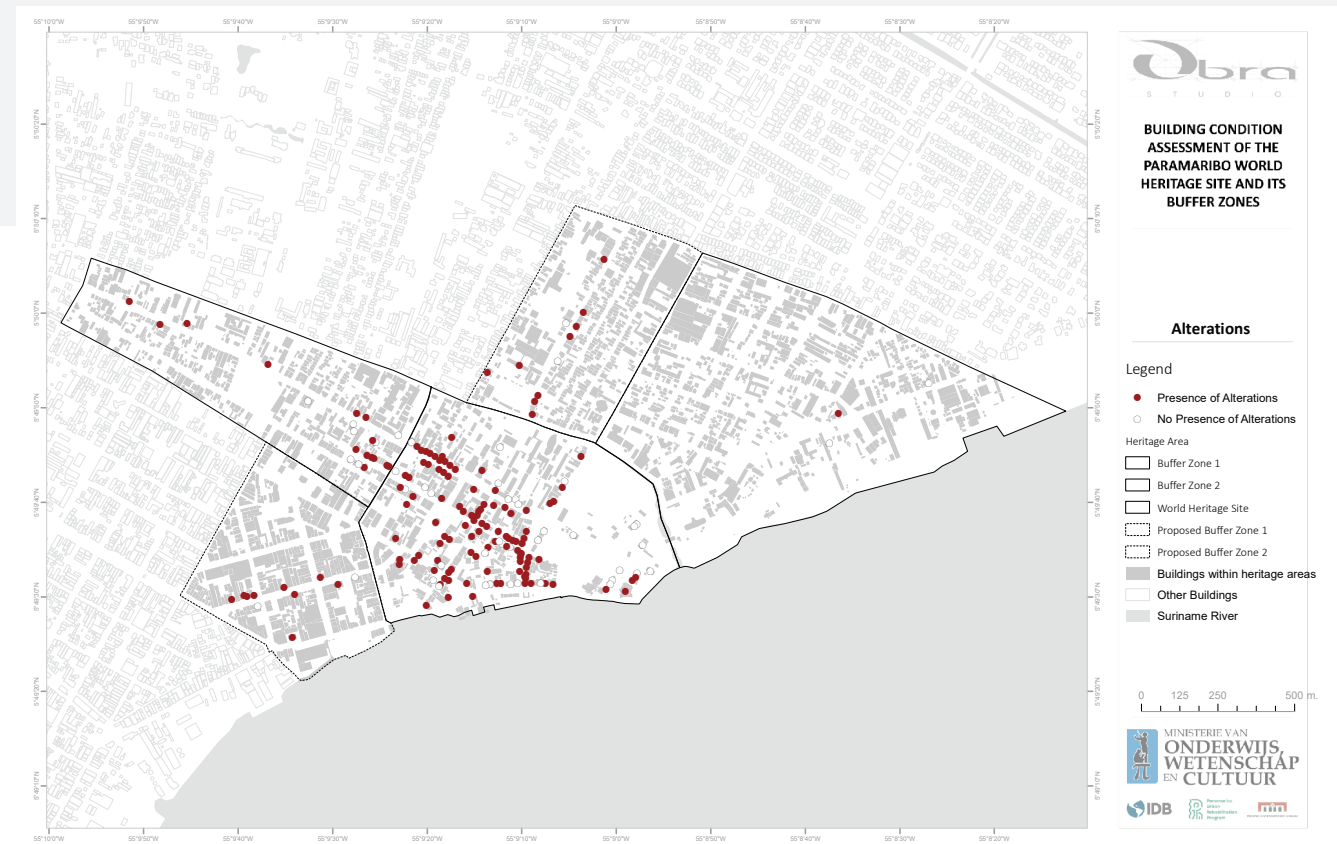
Map 28. Alterations to heritage typologies

Following the elements of value analysis, the survey also contemplated an evaluation of any contextual (urban), typological, morphological, functional, constructive, material, or aesthetic (ornaments) alterations made to the buildings. In particular, when considering alterations to “Heritage Typologies”, figure 27 shows that there is a 74% of alterations. This means that the majority of these buildings have some type of alteration due to new adapted uses, which can either contribute to the building’s value or diminish the building’s value. Figures 28 and 29 demonstrate the relevance of these alterations, and how there should be policies enforced to avoid non-contributing alterations.

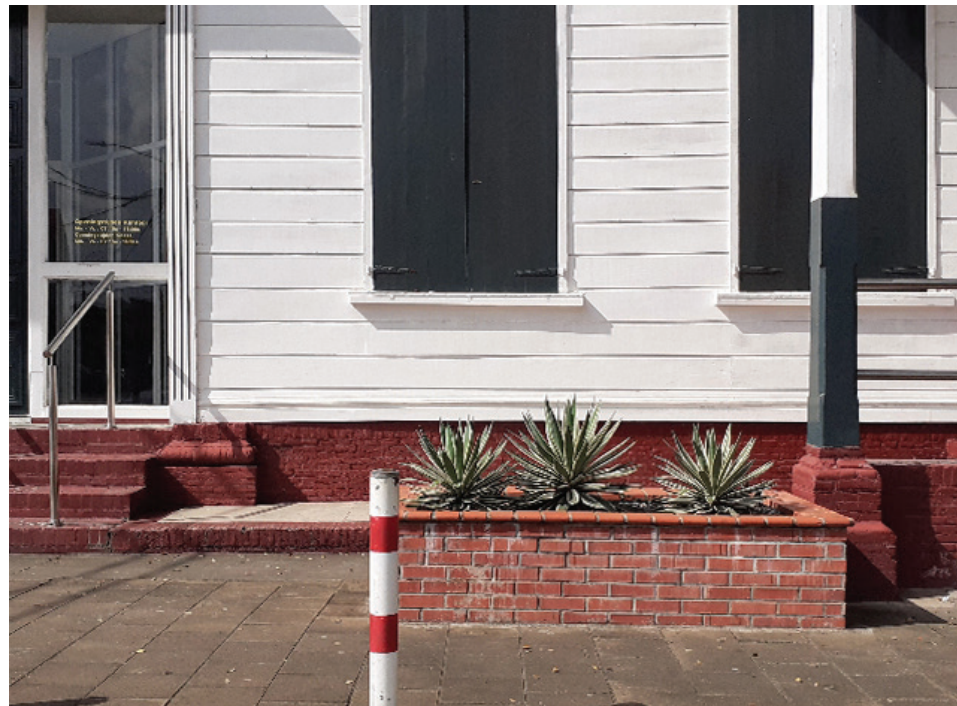
Figure 28. Contributing Alteration

Vegetation is added using the same chromatic spectrum of the building’s foundation, adding value to the quality of the public space.

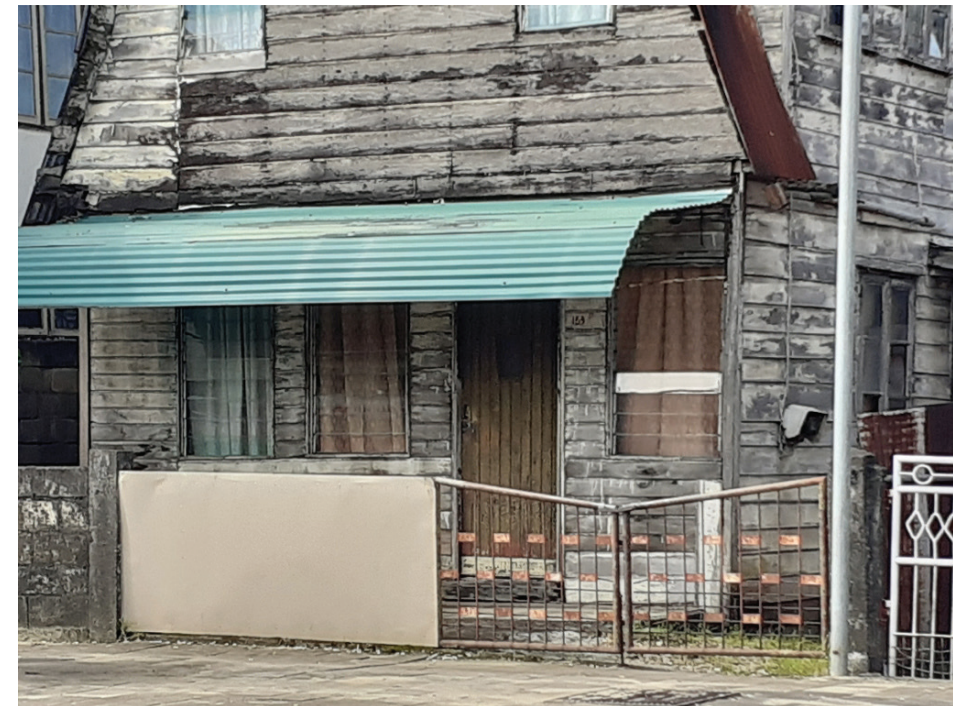
Figure 29. Non Contributing Alteration

A visor-type green structure made of metal was added to the façade, possibly for weather protection, yet it decreases the building’s original value.

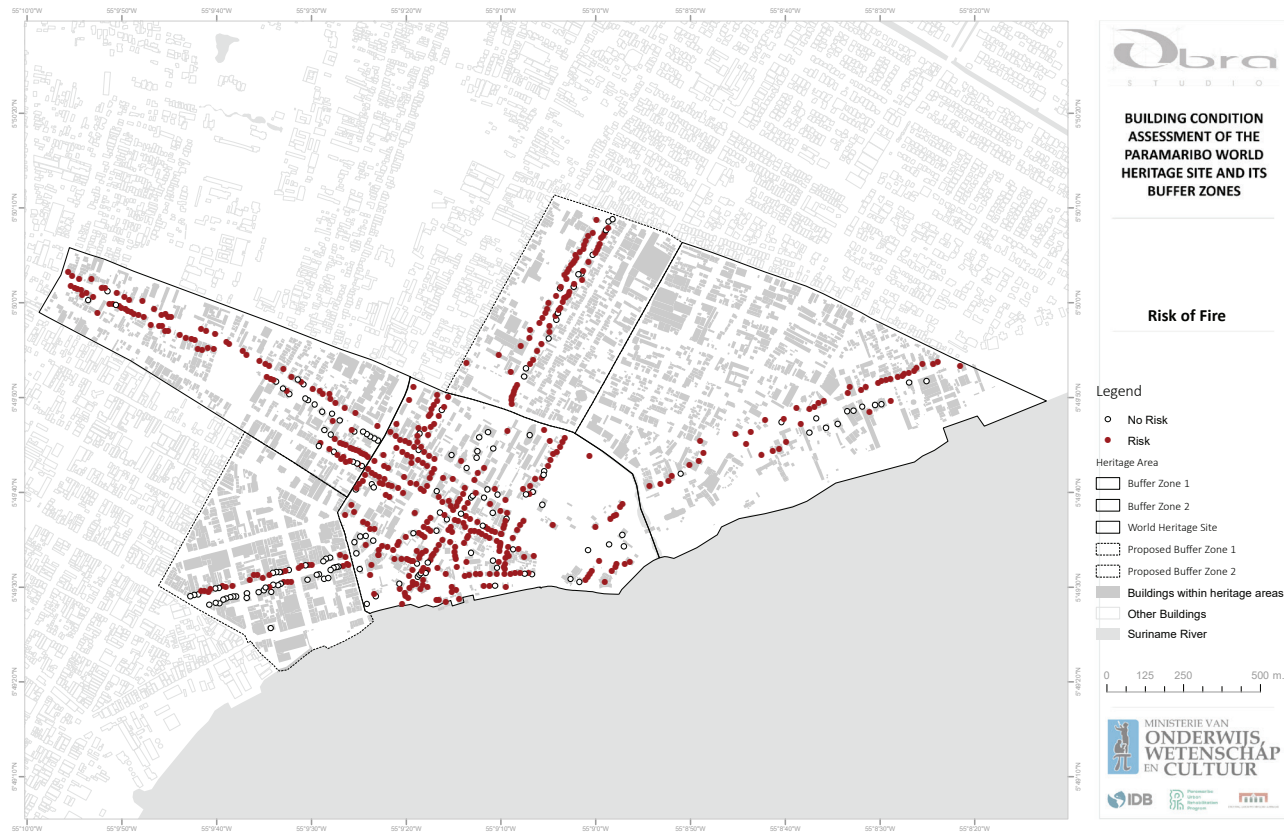
Map 31. Human Risk: Fire due to electrical sources

It is important to note that management mechanisms can be used to reduce and eliminate many of the Human Risks, such as incorporating fire mitigation infrastructure at public spaces. In the case of fire due to electrical sources (map 31), 76% of all buildings were found to be vulnerable, since most buildings in the HICP are close to exposed cables and have insecure connections to the buildings. Furthermore, there is a high limitation of public water installations for fire stations to connect. Another relevant vulnerability is “abandonment”, which is focalized on certain streets, and should be addressed with public incentives. Finally, the risk of “explosions” has a low percentage, but needs to be contemplated into planning; gas stations and gas plants should have strict legal restrictions.

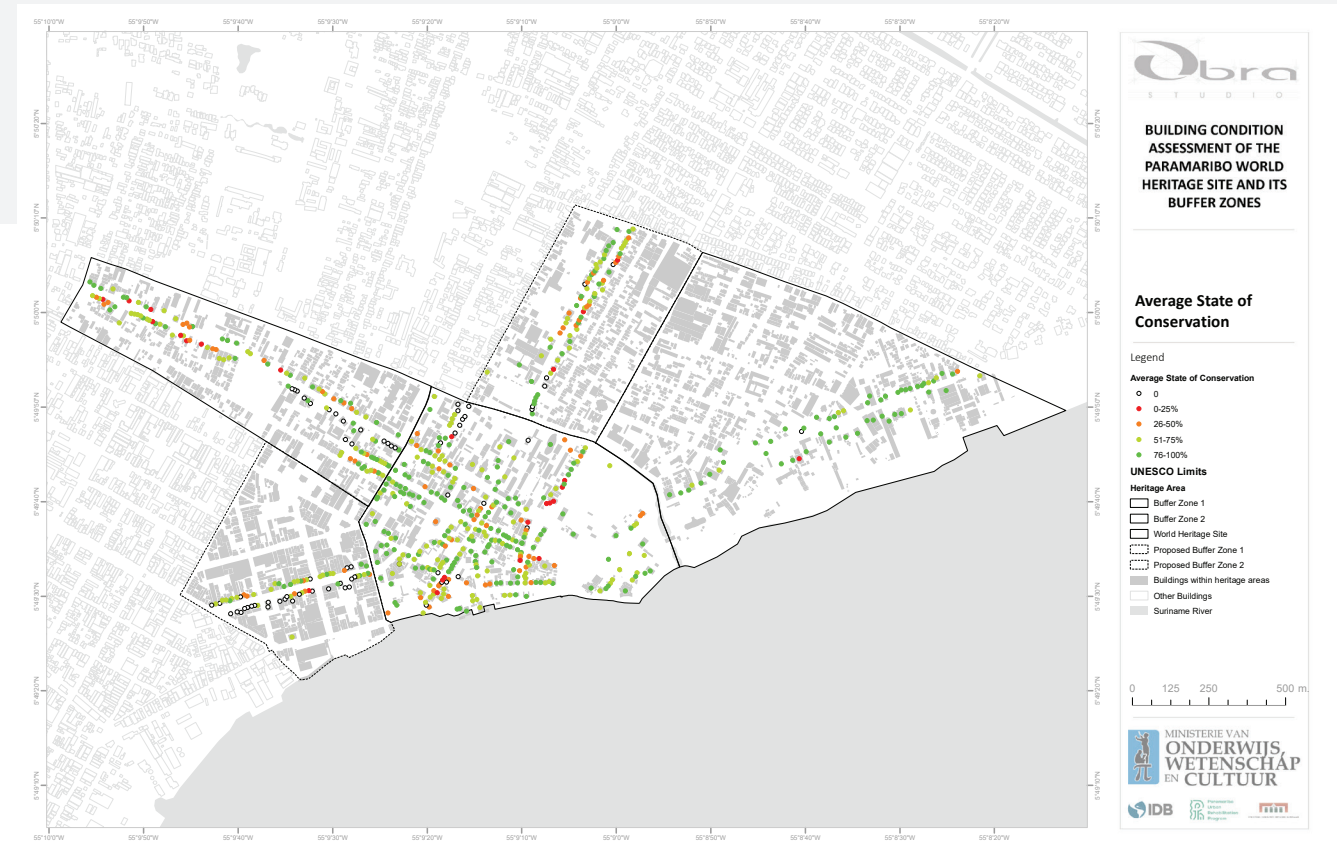
Map 34. Average State of Conservation

The first component for the “Total State of Conservation” is the “Average state of conservation” of every visible element, which was defined in quarters (i.e. 75-100%). In the case of “Average state of conservation”, it can be seen that most of the buildings are in a “good” to “excellent” scale, and the “regular” and “bad” scales are defined by buildings that are concentrated on certain recurrent areas: the commercial area of Maagdenstraat and the southern sections of Watermolenstraat, Jessurunstraat and Henk Arronstraat as shown on Map 34.

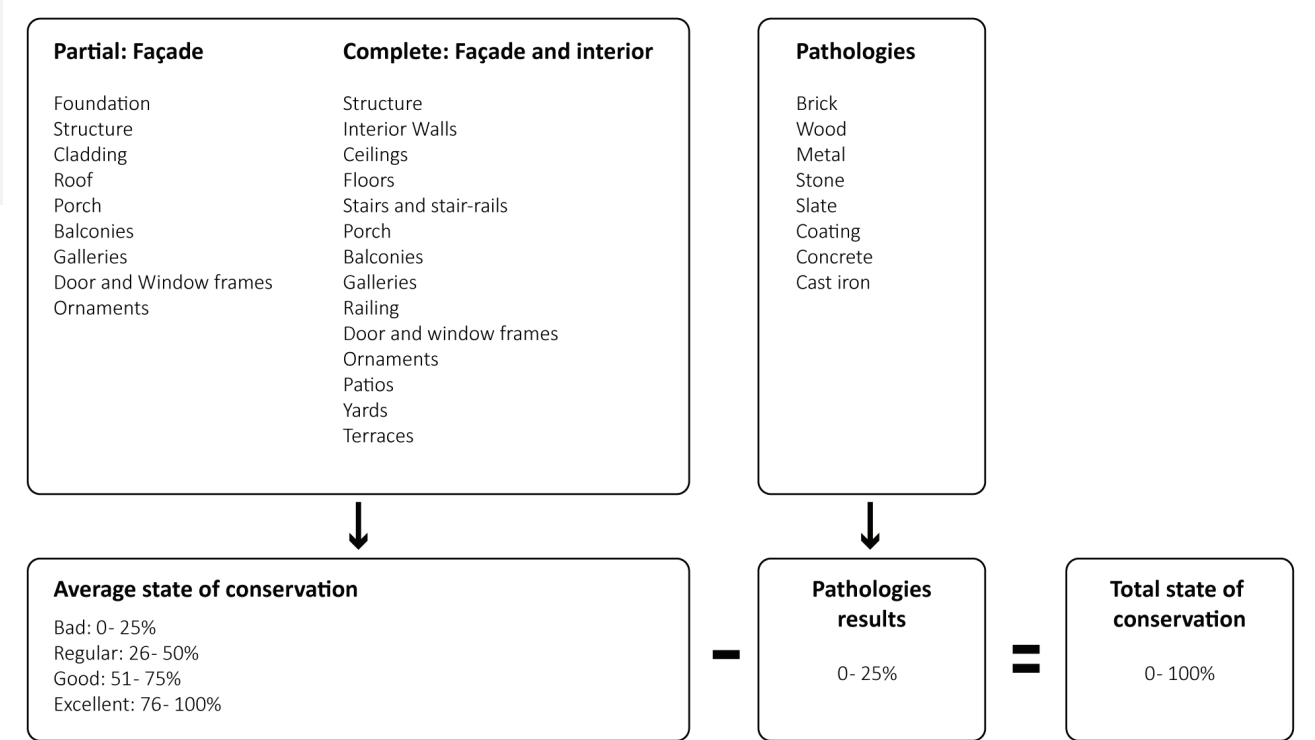
Figure 37. Methodology to calculate “Total State of Conservation”

The methodology to calculate “Total State of Conservation” is based on the two components explained in the last section. Figure 37 shows a diagram of how the two components are calculated to determine a final percentage. This value should be taken as a reference, since most of the analyzed points correspond to the façade analysis and not the complete building. Yet, the results are extremely useful to compare every point and to establish parameters for future interventions.

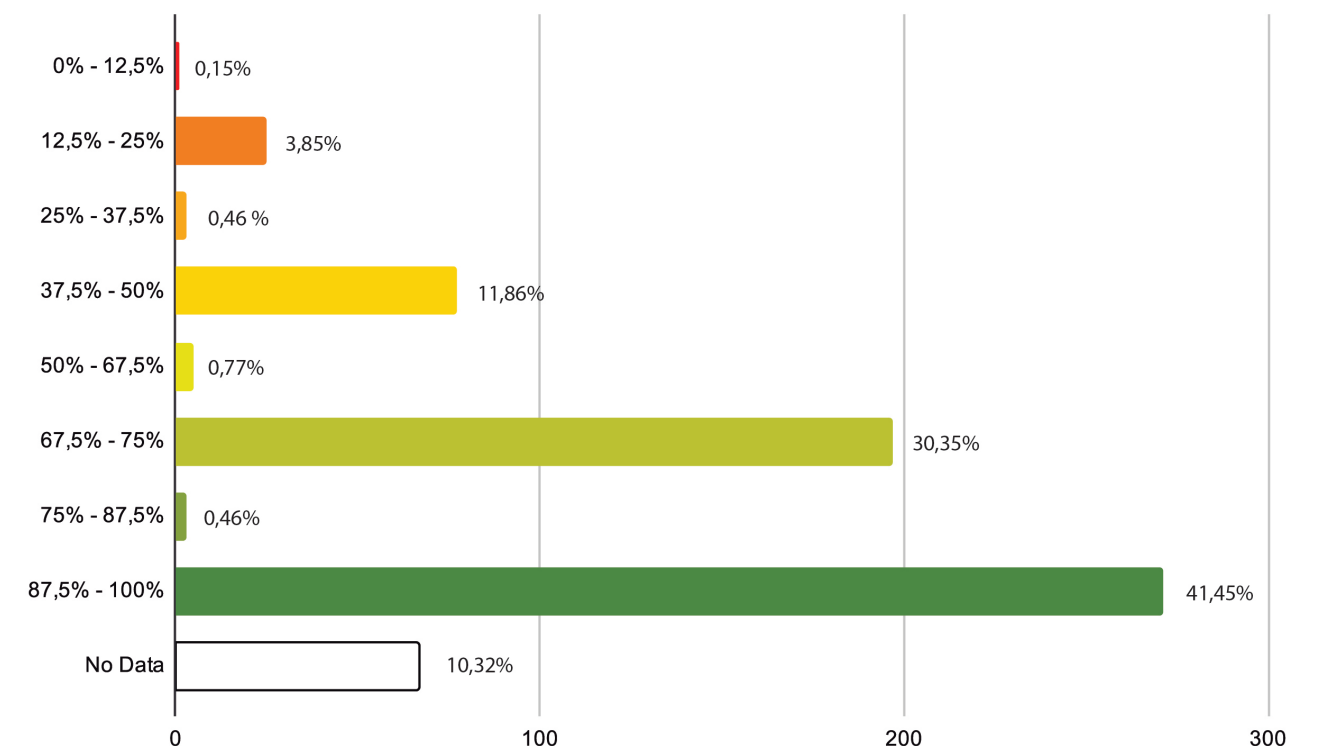
Figure 38. Total State of conservation

Figure 38 shows the results of the “Total state of conservation”. In general, the collected data demonstrates a positive result, where almost three quarters buildings are in the excellent/good ranges. In comparison, the much larger Historic Centre of Quito, also a UNESCO site, has 51% of buildings in excellent/good condition; although, there are over 5,000 properties, so conservation is a larger challenge for that city (IMP, 2019). These values should encourage further renovations, but also the completion of the PHBI, since a high percentage of buildings within the buffer zones were not mapped during this field activities, and those are the areas where degradation is most evidenced.

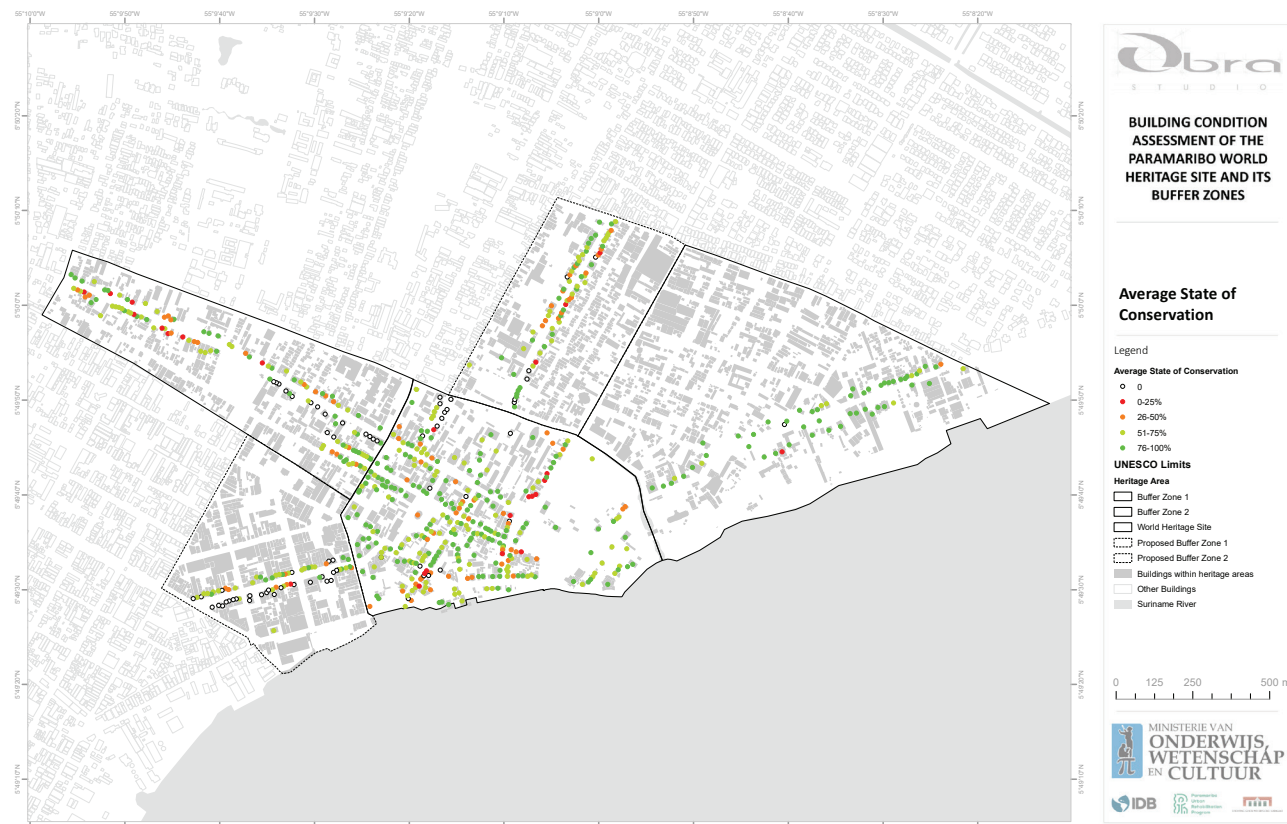
Map 43. Total State of Conservation

As illustrated in the following maps, the priority areas are the southern sections of Watermolenstraat, Jessurunstraat and Henk Arronstraat, and Grote Combeweg. Also, particular attention should be given to the “Proposed Buffer Expansion 2”, since there is a generalized degradation along the commercial Maagdenstraat. The southern section of Henk Arronstraat also shows a considerable concentration of degraded buildings.

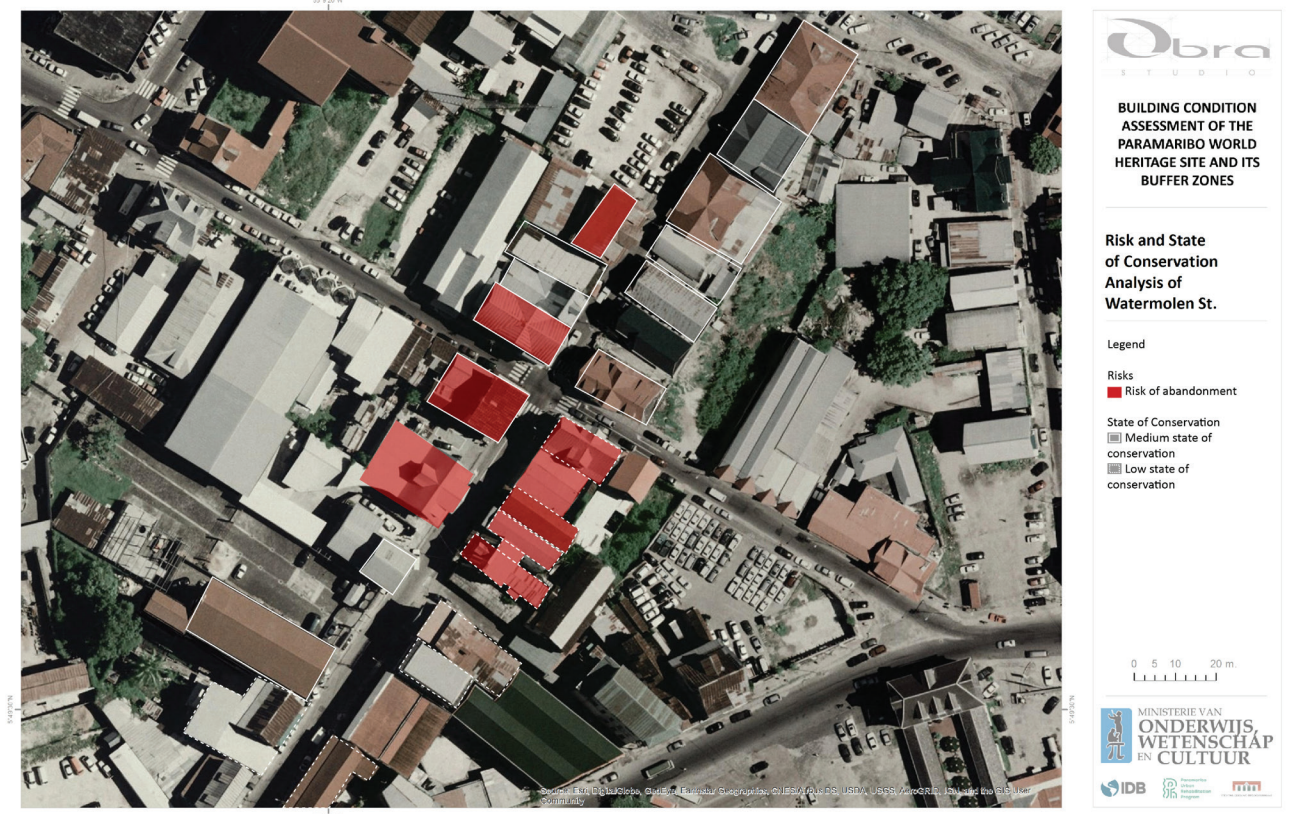
Map 51. Risk and State of Conservation at Watermolen Straat

- The study shows that the commercial area of Maagdenstraat and the southern sections of Watermolenstraat, Jessurunstraat and Henk Arronstraat are problematic areas that have low state of conservation, social conflicts and high rates of abandonment. As an example, map 51 shows the southern section of Watermolenstraat, where there are buildings with low state of conservation and risk of abandonment. Future urban planning strategies should have socioeconomic strategies to improve the conditions in these, for they currently interrupt the flow of transients due to a high perception of insecurity.
